NASA/TP-97-206257

The Characteristics of Fatigue Damage in the Fuselage Riveted Lap Splice Joint

Robert S. Piascik
Langley Research Center, Hampton, Virginia

November 1997

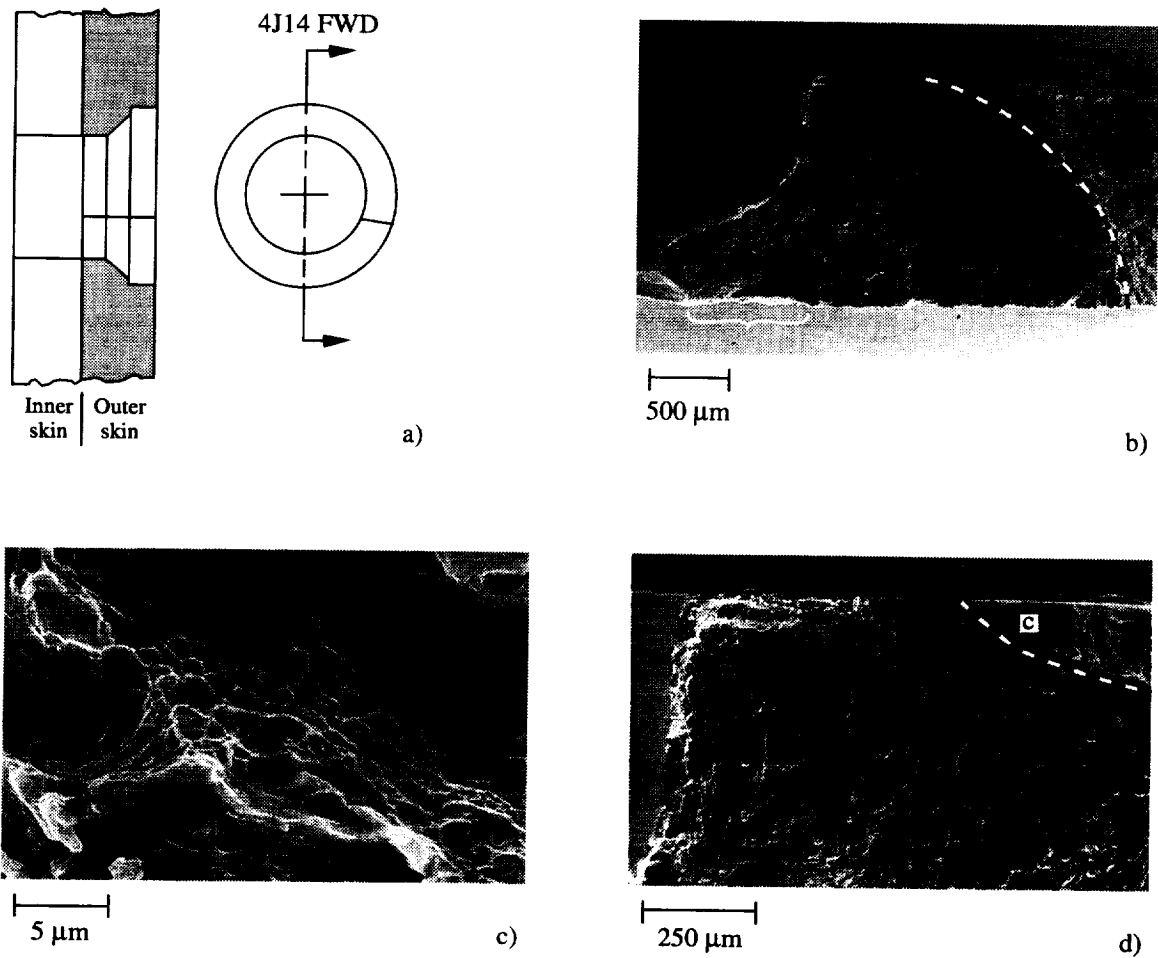
Figure 11.34 a) The schematic shows the rivet hole 4J14 configuration and the location of the outer skin fatigue crack oriented in the forward direction and about the 4 o'clock position. b) The SEM micrograph shows the fatigue crack fracture surface located at the outer skin rivet hole (left). The bracket marks the likely crack initiation site and the dashed line marks the fatigue crack front. c) The SEM micrograph shows the ductile tearing morphology of the overload fracture surface at region "c" in Figure 11.11.d at high magnification. d) The SEM micrograph shows the fatigue crack front region (dashed line) as it intersects the outboard surface of the outer skin. The rivet hole is located to the left.

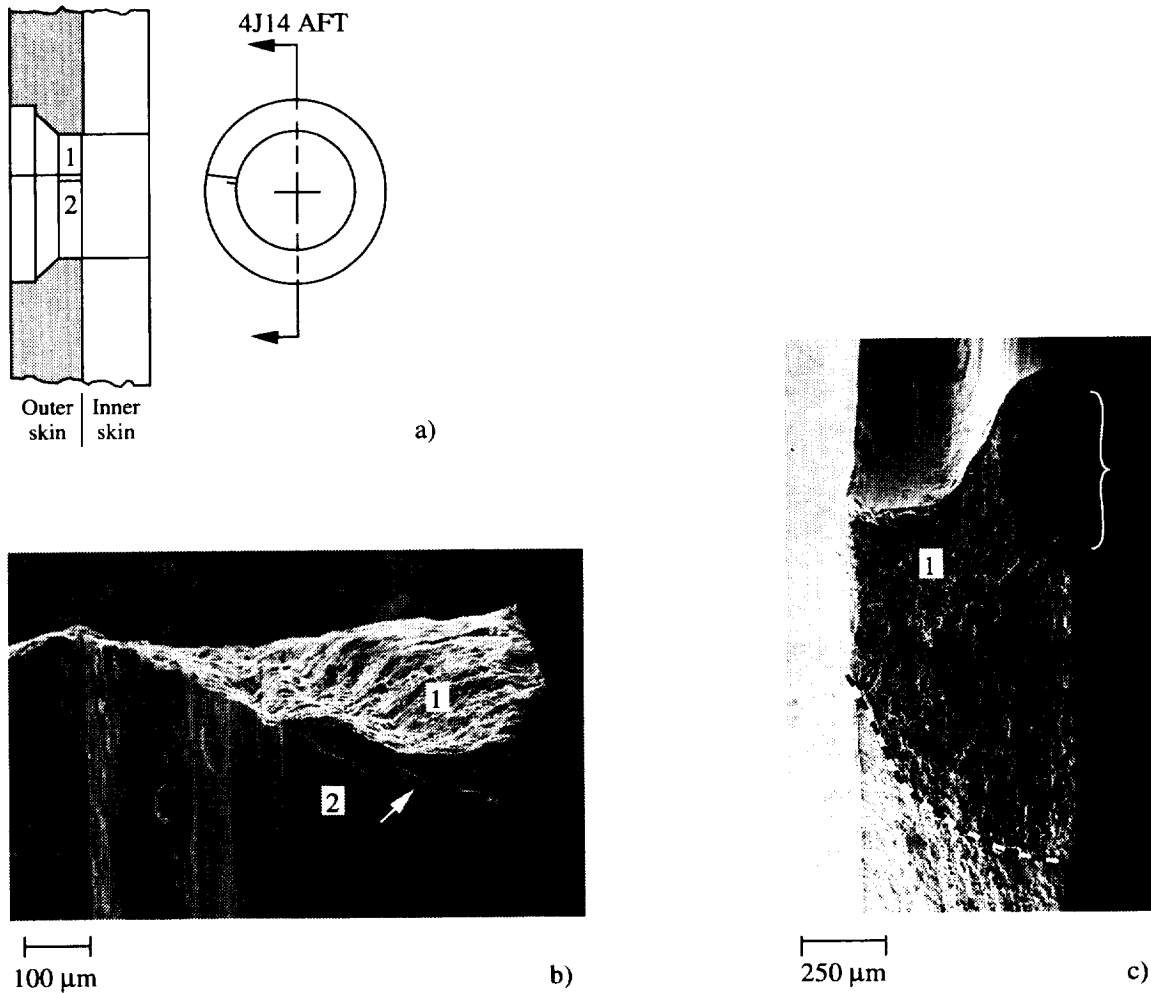
Figure 11.35 a) The schematic shows the rivet hole 4J14 configuration and the location of two outer skin fatigue cracks oriented in the aft direction and above the 9 o'clock position. b) The SEM micrograph shows the rivet hole surface and the fatigue crack fracture surface at an oblique angle. Fatigue crack #2 is located below the main fracture surface that contains fatigue crack #1. c) The SEM micrograph shows the fatigue crack fracture surface located at the outer skin rivet hole (top). The bracket marks the likely region of crack initiation along the faying surface and the dashed line marks the fatigue crack front.

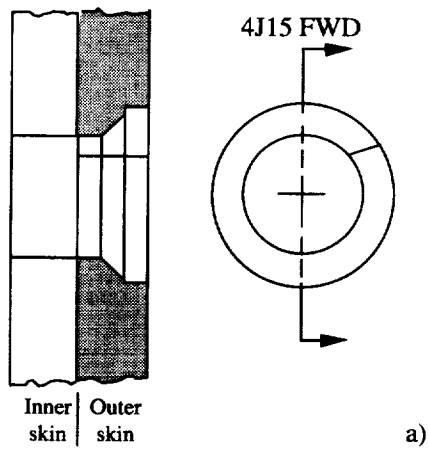
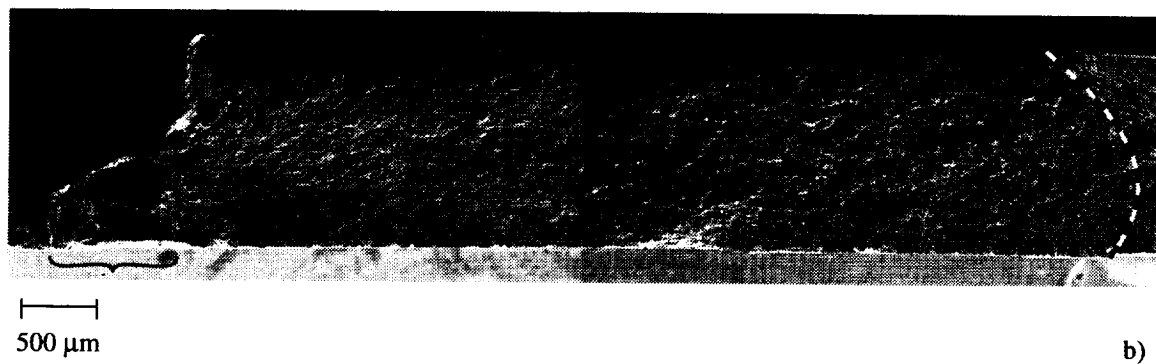
Figure 11.36 a) The schematic shows the rivet hole 4J15 configuration and the location of the outer skin fatigue crack oriented in the forward direction and about the 2 o'clock position. b) The SEM micrograph shows the fatigue crack fracture surface located at the outer skin rivet hole (left). The bracket marks the region of crack initiation along the faying surface and the dashed line marks the fatigue crack front.

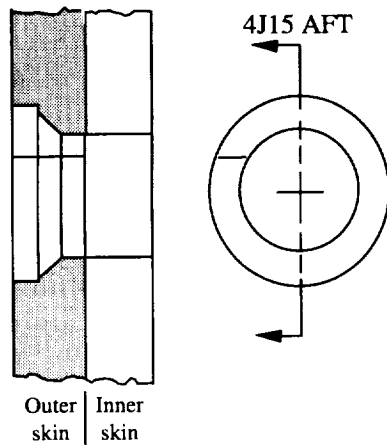
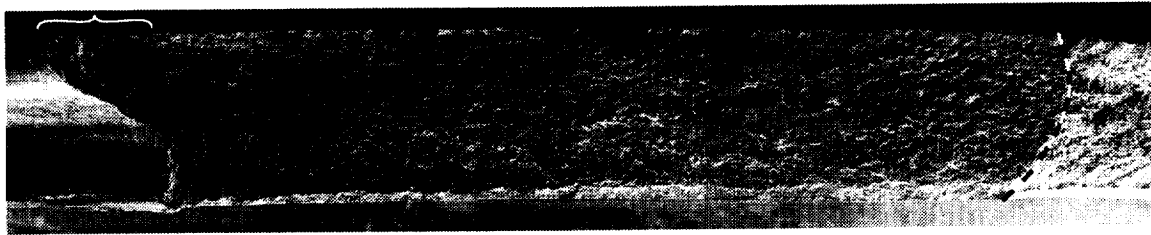
Figure 11.37 a) The schematic shows the rivet hole 4J15 configuration and the location of the outer skin fatigue crack oriented in the aft direction and about the 10 o'clock position. b) The SEM micrograph shows the fatigue crack fracture surface located at the outer skin rivet hole (left). The bracket marks the region of crack initiation along the faying surface and the dashed line marks the fatigue crack front.

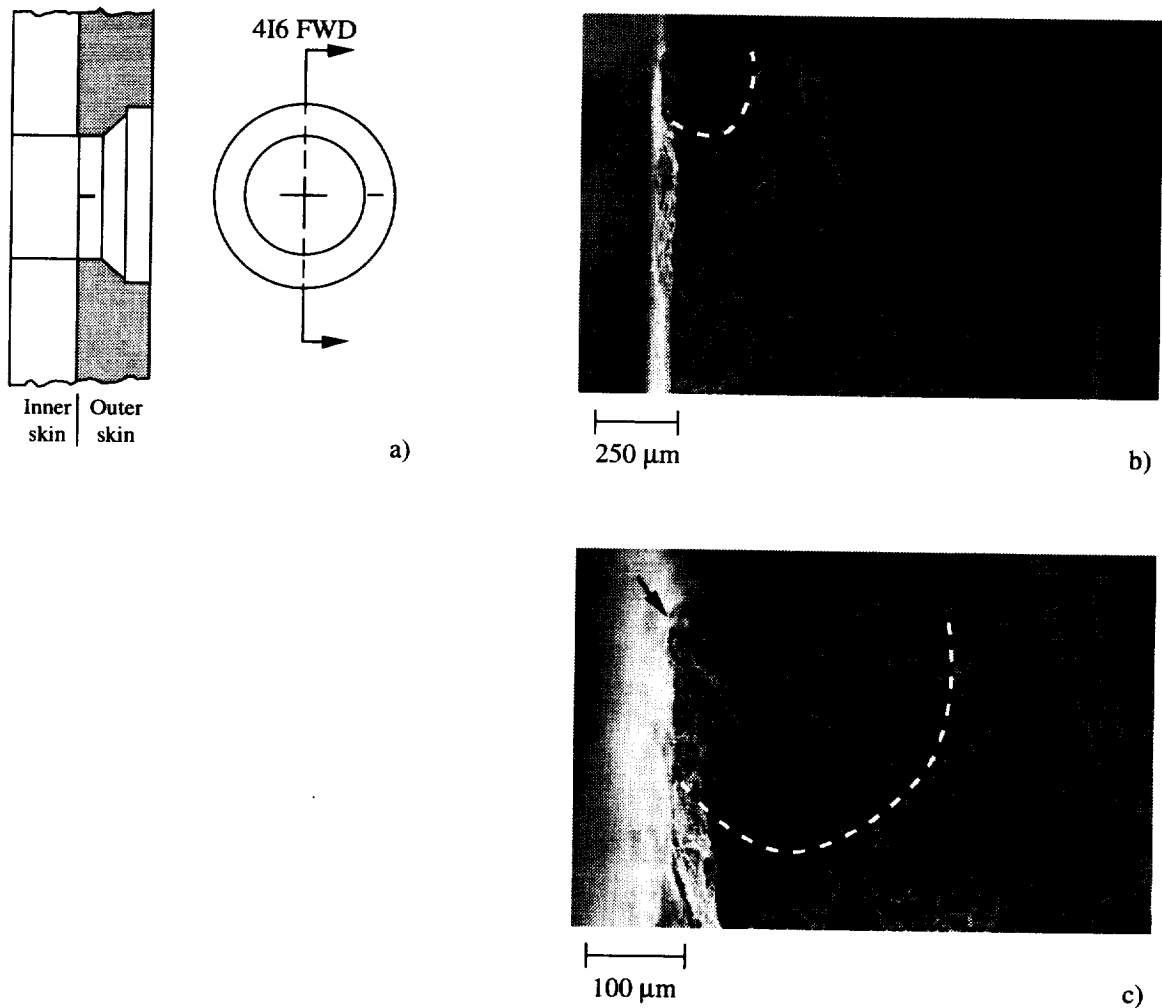
Figure 11.38 a) The schematic shows the rivet hole 4I6 configuration and the location of the outer skin fatigue crack oriented in the forward direction and about the 3 o'clock position. b) The SEM micrograph shows the fatigue crack fracture surface located at the outer skin rivet hole (top). The dashed line marks the fatigue crack front. c) The SEM micrograph shows the fatigue crack fracture surface at the rivet hole shank region. The arrow marks the likely site of crack initiation and the dashed line marks the fatigue crack front.

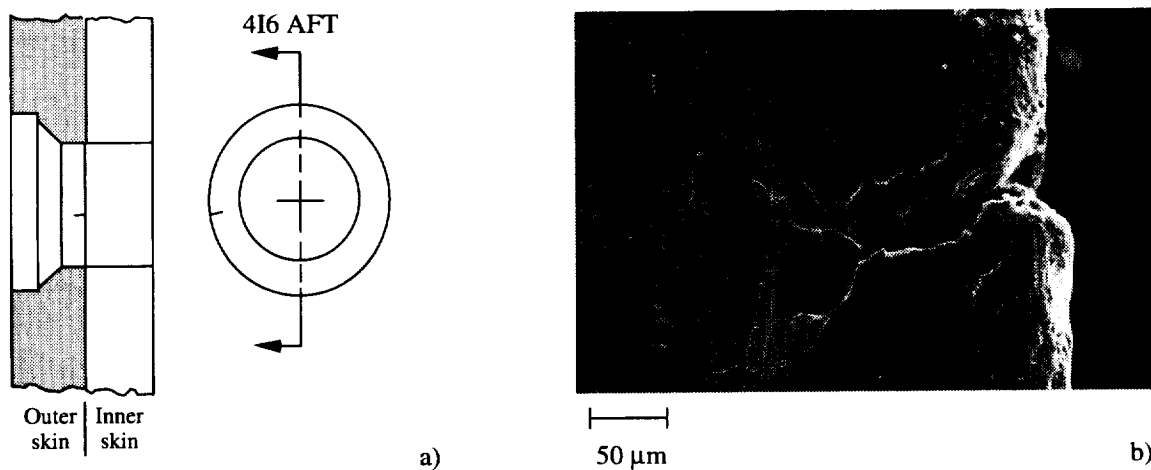
Figure 11.39 a) The schematic shows the rivet hole 4I6 configuration and the location of the outer skin fatigue crack oriented in the aft direction and below the 9 o'clock position. b) The SEM micrograph shows the small partially opened fatigue crack located at the inboard corner of the rivet hole shank region. The crack was partially opened during the destructive examination.

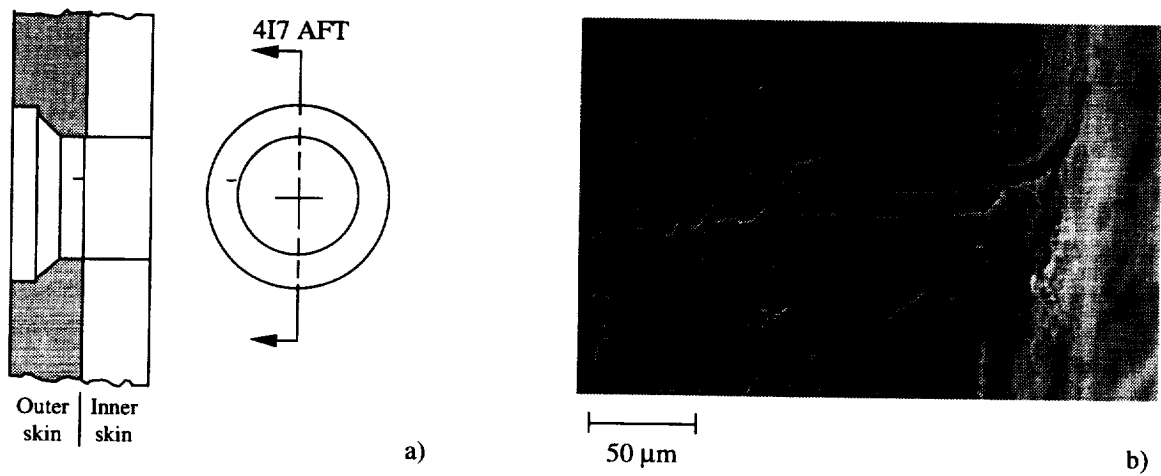
Figure 11.40 a) The schematic shows the rivet hole 4I7 configuration and the location of the outer skin fatigue crack oriented in the aft direction and above the 9 o'clock position. b) The SEM micrograph shows the small partially opened fatigue crack located at the inboard corner of the rivet hole shank region. The crack was partially opened during the destructive examination.

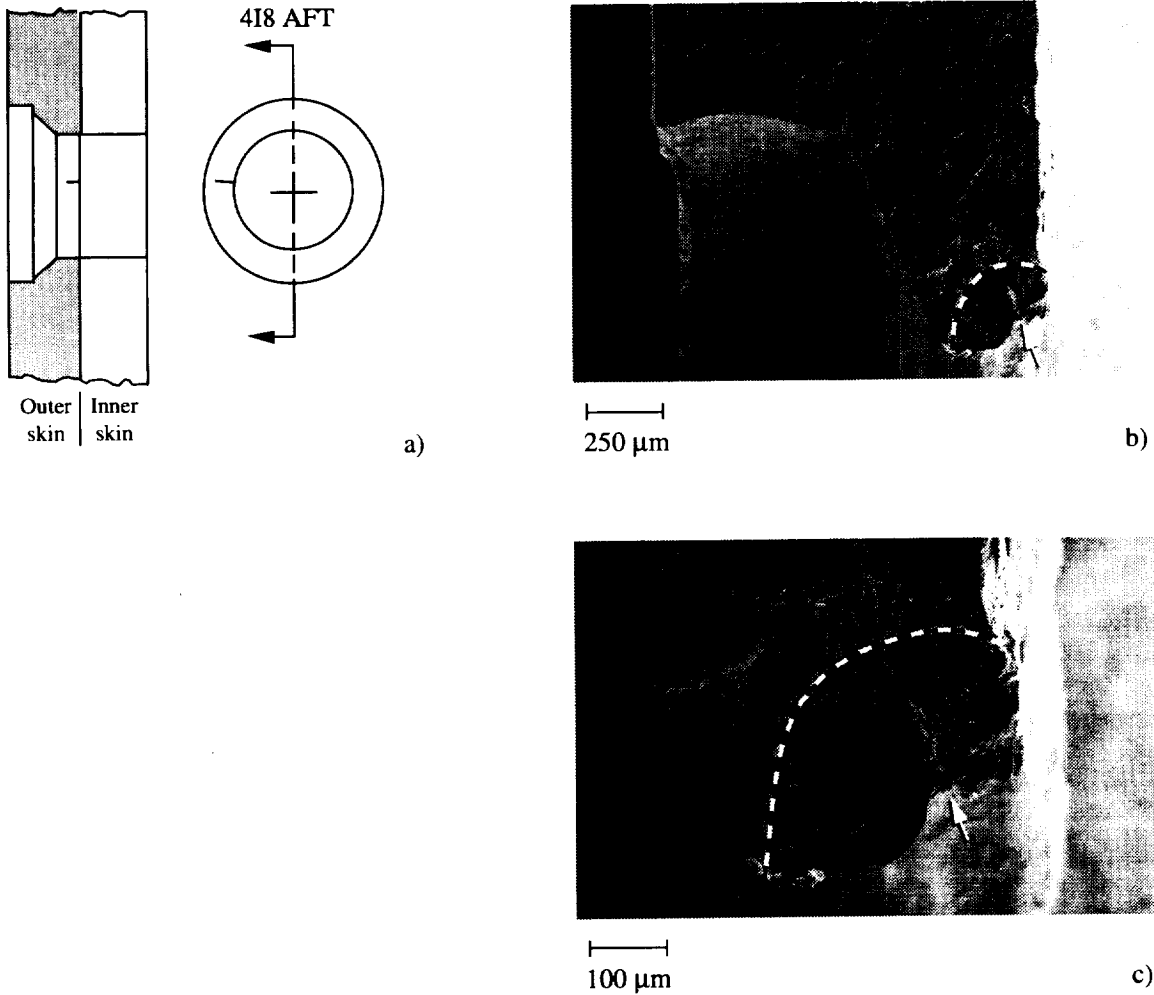
Figure 11.41 a) The schematic shows the rivet hole 4I8 configuration and the location of the outer skin fatigue crack oriented in the aft direction and above the 9 o'clock position. b) The SEM micrograph shows the fatigue crack fracture surface located at the outer skin rivet hole (bottom). The arrow marks the likely crack initiation site and the dashed line marks the fatigue crack front at high magnification. c) The SEM micrograph shows the fatigue crack fracture surface at the rivet hole shank region. The arrow marks the likely site of crack initiation and the dashed line marks the fatigue crack front.

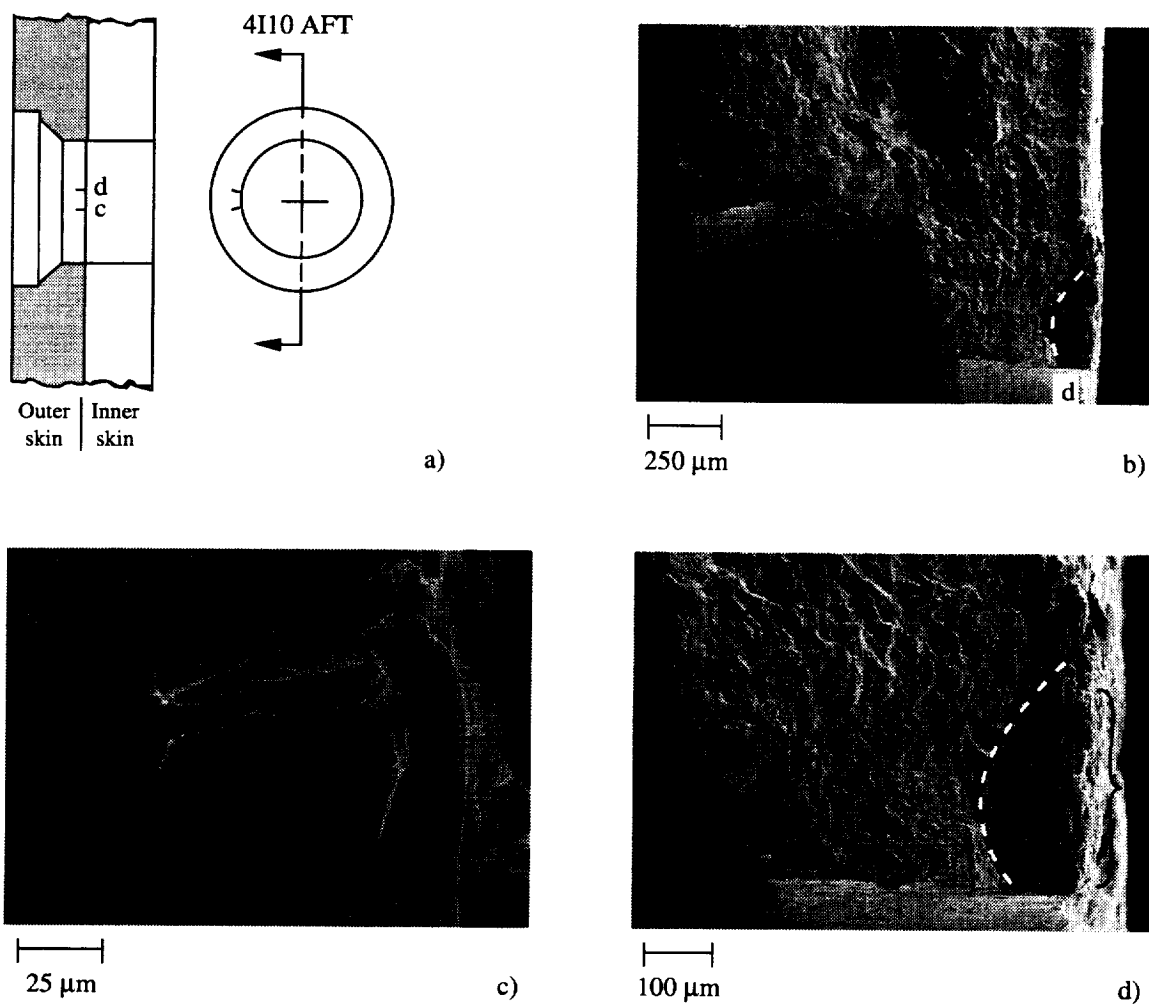
Figure 11.42 a) The schematic shows the rivet hole 4I10 configuration and the location of two outer skin fatigue cracks oriented in the aft direction and about the 9 o'clock position. b) The SEM micrograph shows the fatigue crack fracture surface located at the outer skin rivet hole (bottom). The dashed line marks the fatigue crack front. c) The SEM micrograph shows the inside surface of the rivet hole and a small partially opened fatigue crack (crack "c" in Figure 11.39.a) located at the inboard corner of the rivet hole. d) The SEM micrograph shows the fatigue crack fracture surface (crack "d" in Figure 11.39.a) at the rivet hole shank region at high magnification. The bracket marks the likely region of crack initiation along the faying surface and the dashed line marks the fatigue crack front.

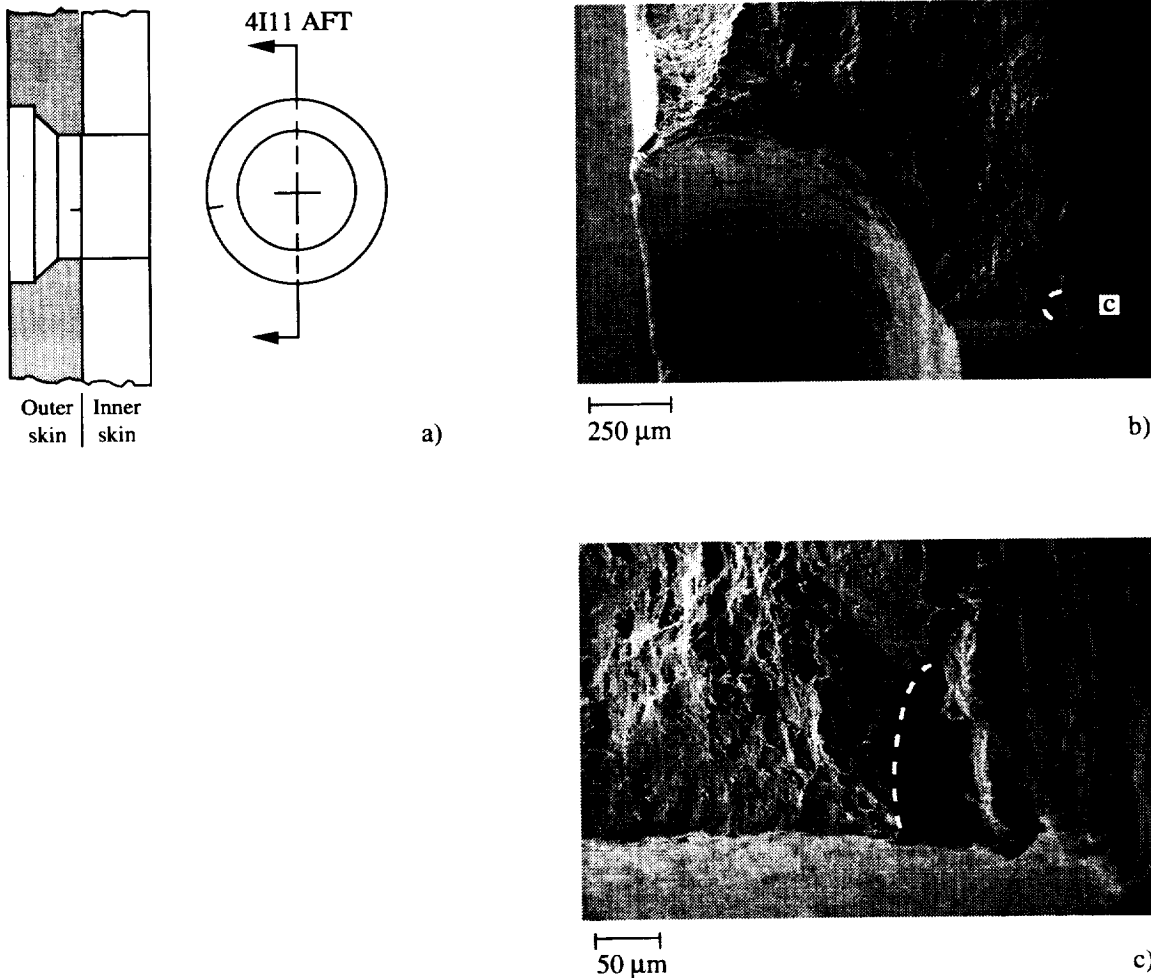
Figure 11.43 a) The schematic shows the rivet hole 4I11 configuration and the location of the outer skin fatigue crack oriented in the aft direction and below the 9 o'clock position. b) The SEM micrograph shows the location of a small fatigue crack (region "c") located at the inboard corner of the outer skin rivet hole. c) The SEM micrograph shows the fatigue crack, region "c" in Figure 11.40.b, located at the rivet hole shank region at high magnification. The dashed line marks the fatigue crack front.

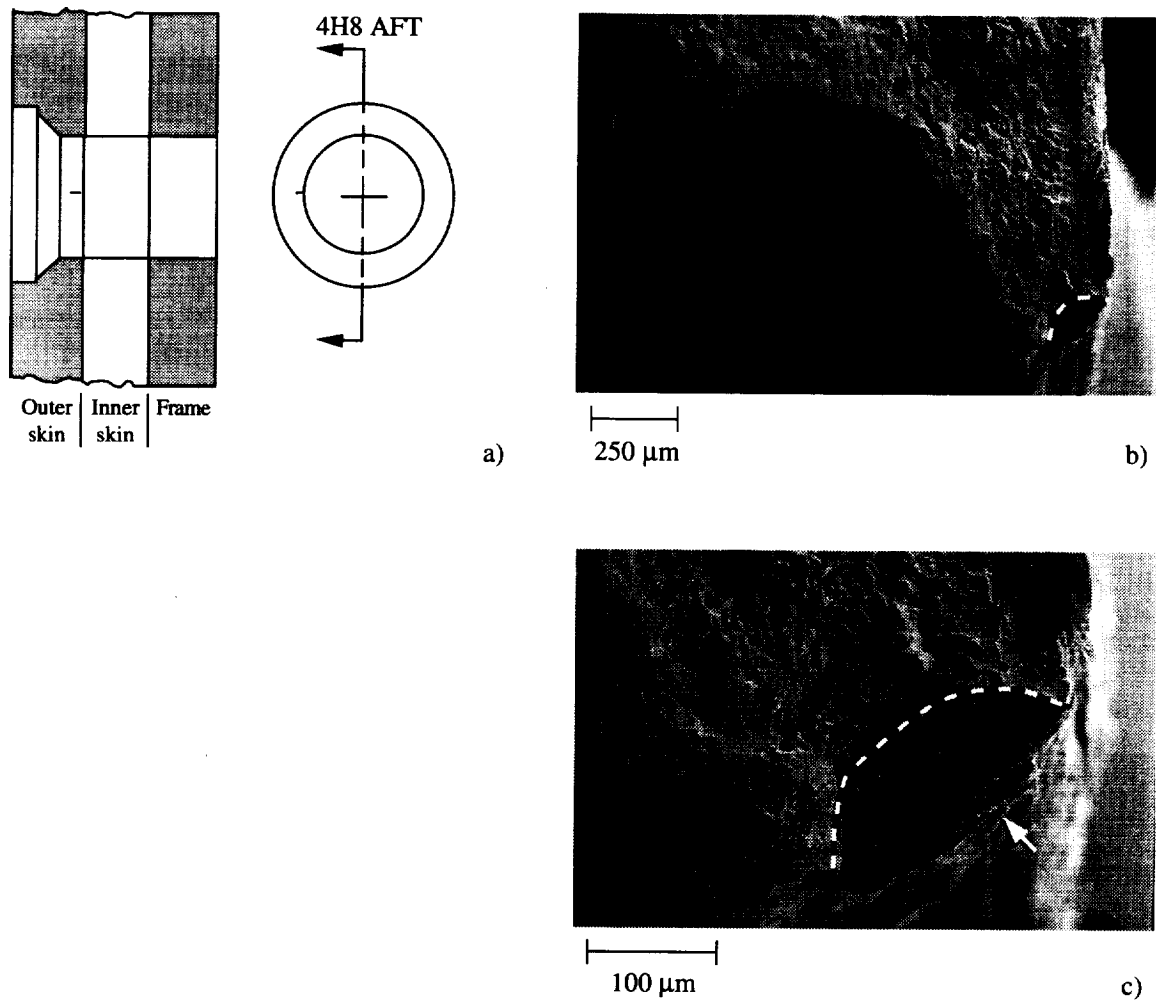
Figures 11.44 through 11.45 describe the fatigue crack morphology in row H.

Figure 11.44 a) The schematic shows the rivet hole 4H8 configuration and the location of the outer skin fatigue crack oriented in the aft direction and about the 9 o'clock position. b) The SEM micrograph shows the location of a small fatigue crack located at the inboard corner of the outer skin rivet hole. The dashed line marks the fatigue crack front. c) The SEM micrograph shows the fatigue crack fracture surface at the rivet hole shank region at high magnification. The arrow marks the likely site of crack initiation and the dashed line marks the fatigue crack front.

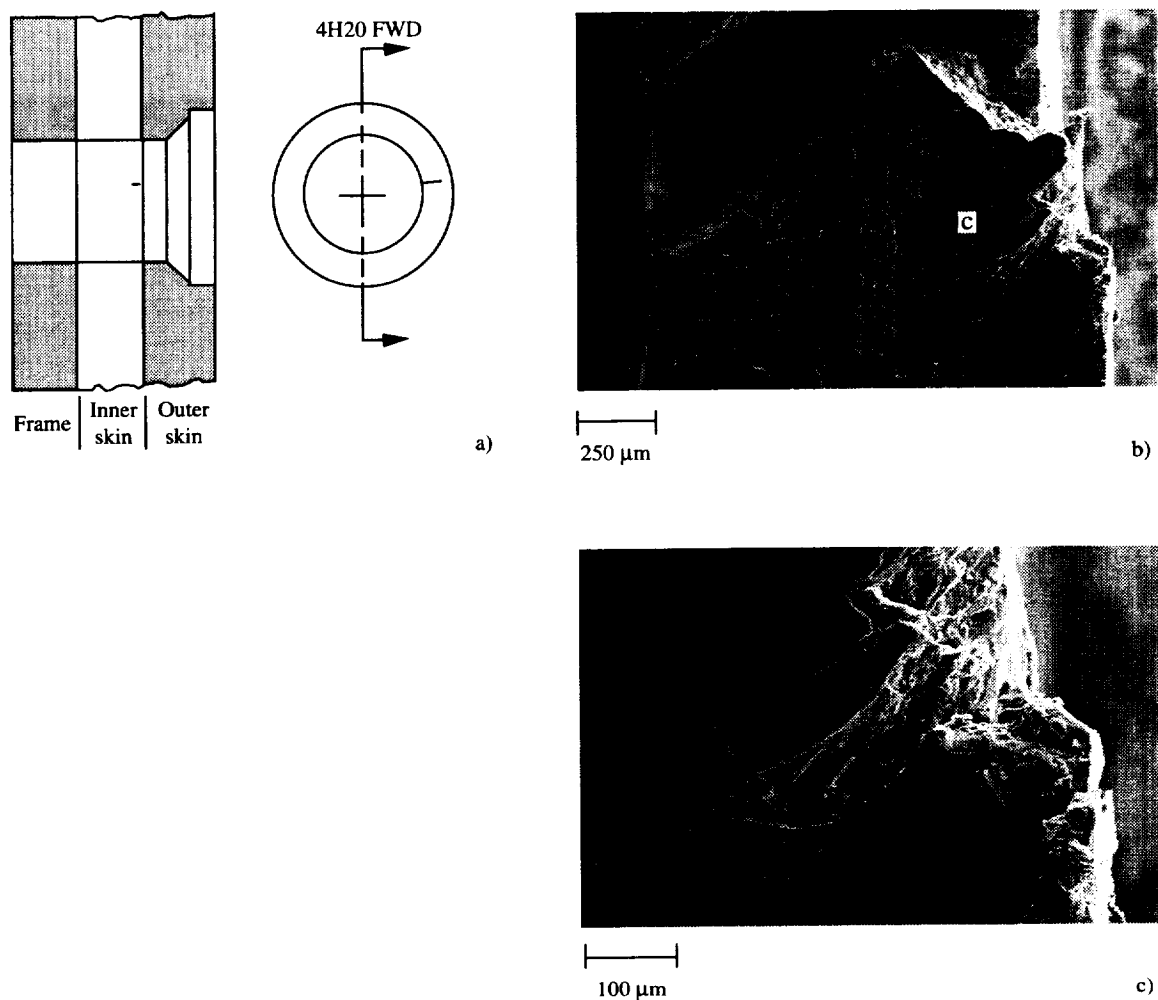
Figure 11.45 a) The schematic shows the rivet hole 4H20 configuration and the location of the inner skin fatigue crack oriented in the forward direction and above the 3 o'clock position. b) The SEM micrograph shows the inside surface of the inner skin rivet hole. A small partially opened fatigue crack is located below the main fracture surface at region "c". The crack was partially opened during the destructive examination. c) The SEM micrograph shows the small partially opened fatigue crack at high magnification at region "c" in Figure 11.42.b. The fatigue crack is located near the outboard corner of the inner skin.

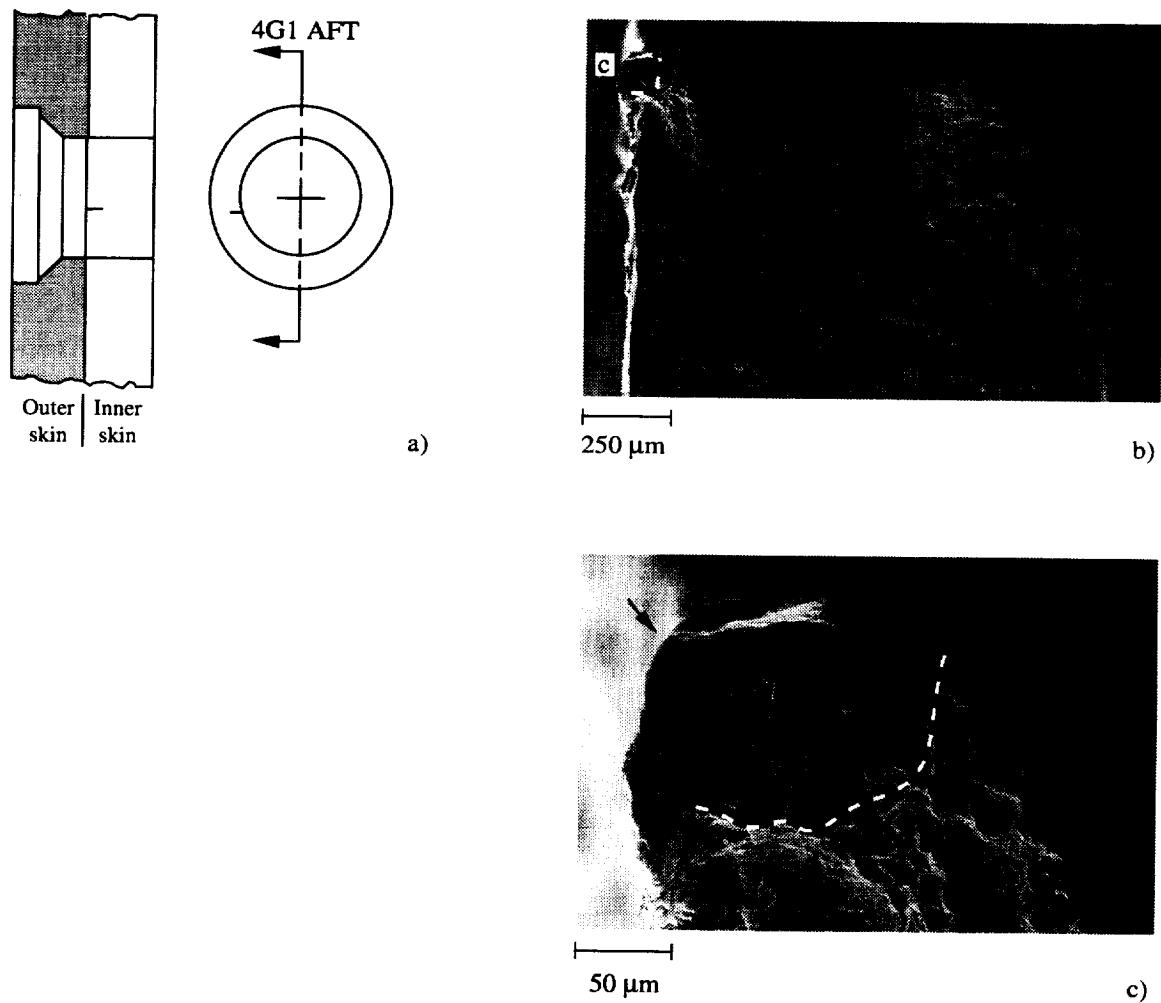
Figures 11.46 through 11.48 describe the fatigue crack morphology in row G.

Figure 11.46 a) The schematic shows the rivet hole 4G1 configuration and the location of the inner skin fatigue crack oriented in the aft direction and below the 9 o'clock position. b) The SEM micrograph shows a small fatigue crack (region "c") located at the outboard corner of the inner skin rivet hole. The dashed line marks the fatigue crack front. c) The SEM micrograph shows the small fatigue crack region at high magnification. The arrow marks the likely site of fatigue crack initiation and the dashed line marks the fatigue crack front.

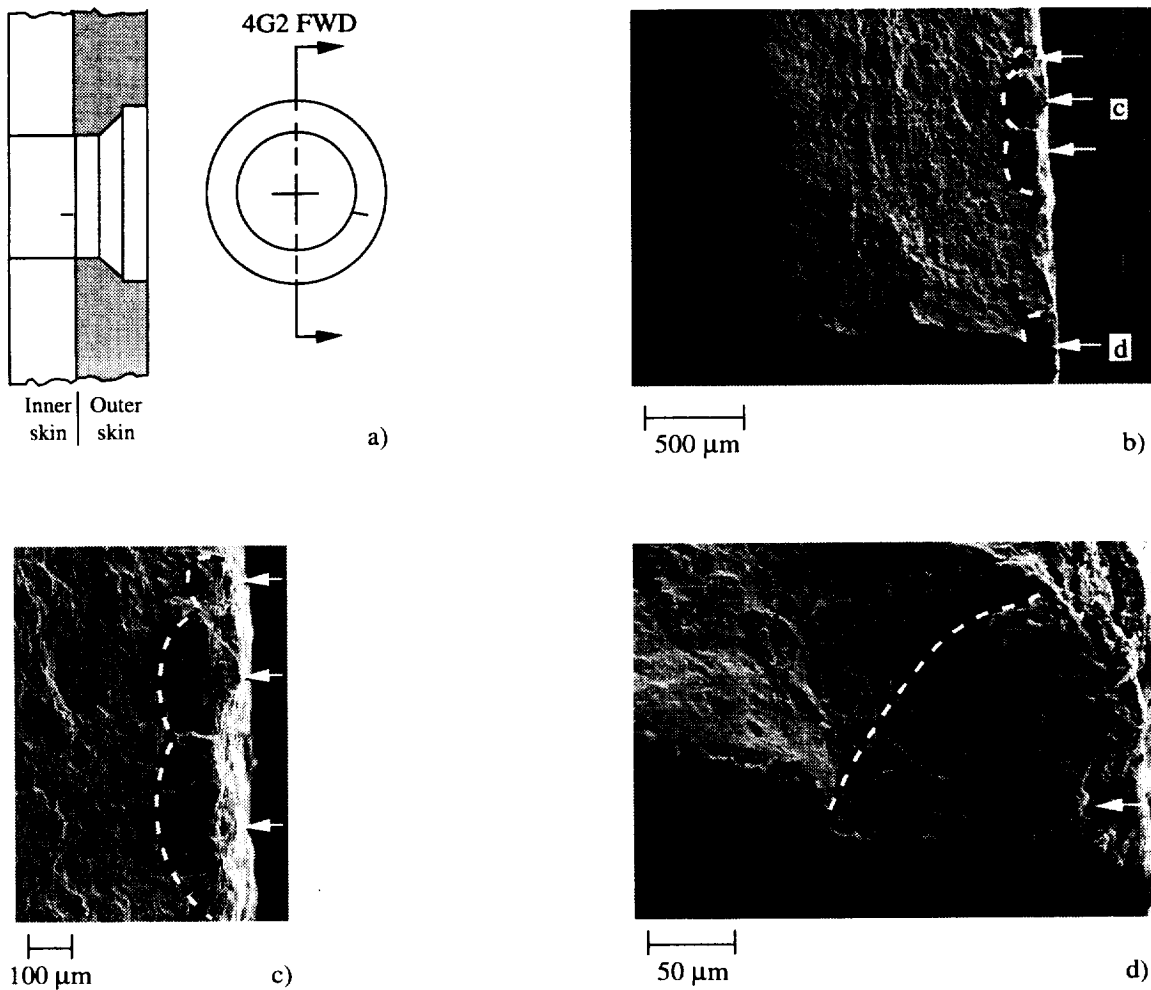
Figure 11.47 a) The schematic shows the rivet hole 4G2 configuration and the location of the outer skin fatigue crack oriented in the forward direction and about the 4 o'clock position. b) The SEM micrograph shows the location of small fatigue cracks located at the outboard corner and faying surface of the inner skin. The arrows mark the likely sites of fatigue crack initiation and the dashed lines mark the fatigue crack fronts. c) The SEM micrograph shows the fatigue crack, region "c" in Figure 11.44.b, along the inner skin faying surface at high magnification. The arrow marks likely sites of crack initiation and the dashed line marks the fatigue crack front. d) The SEM micrograph shows the outboard corner fatigue crack at region "d" in Figure 11.44.b. The arrow marks the crack initiation site and the dashed line marks the crack front.

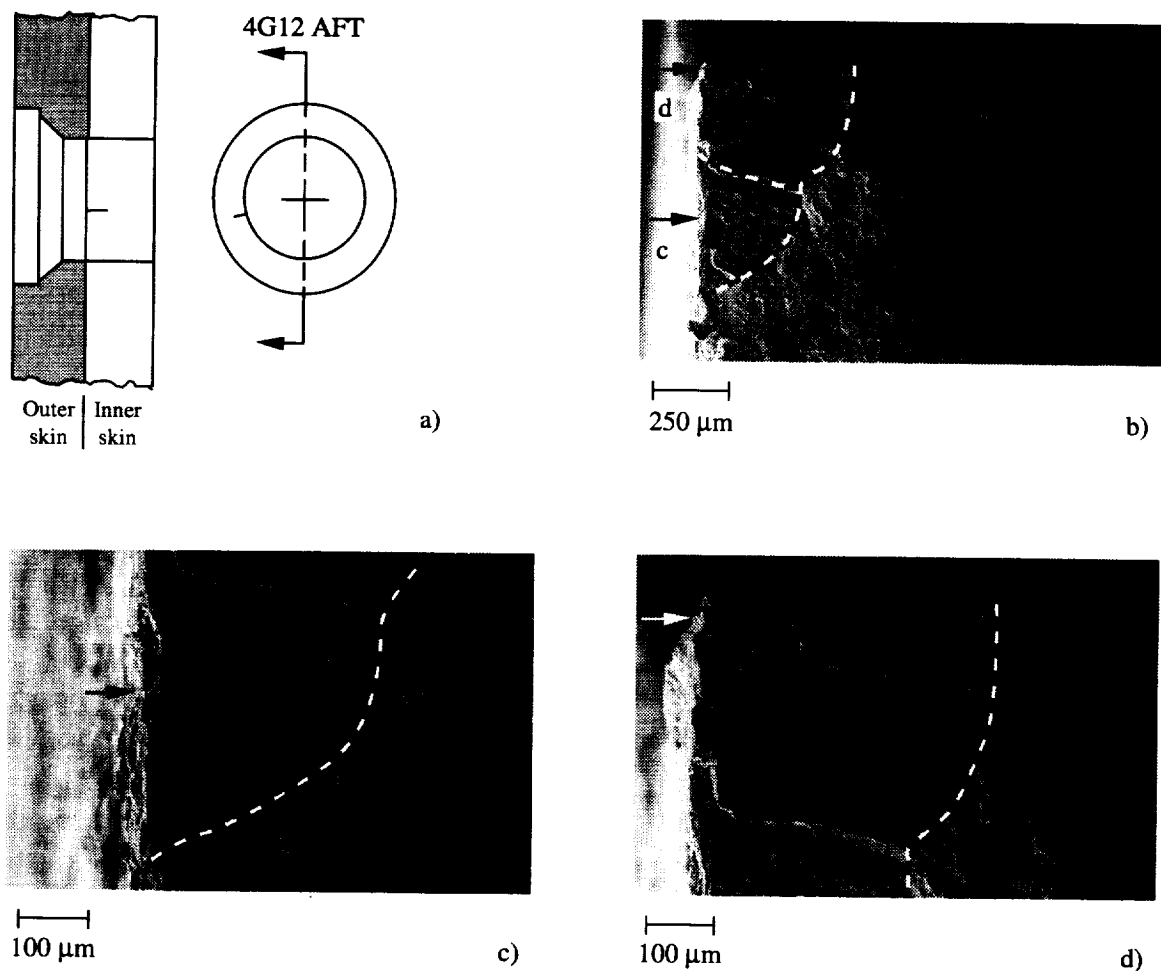
Figure 11.48 a) The schematic shows the rivet hole 4G12 configuration and the location of the inner skin fatigue crack oriented in the aft direction and below the 9 o'clock position. b) The SEM micrograph shows the fatigue crack fracture surface located at the outboard corner of the inner skin rivet hole. The arrows mark likely sites of crack initiation along the faying surface. The irregular shape of the fatigue crack front marked by the dashed lines suggests that two fatigue cracks coalesced at the fracture surface ridge (horizontal dashed line). c) The SEM micrograph shows the fatigue crack, region "c" in Figure 11.45.b, at high magnification. The arrow marks the crack initiation site and the dashed line marks the fatigue crack front. d) The SEM micrograph shows the fatigue crack region "d" in Figure 11.45.b at high magnification. The arrow marks the crack initiation site and the dashed line marks the fatigue crack front.

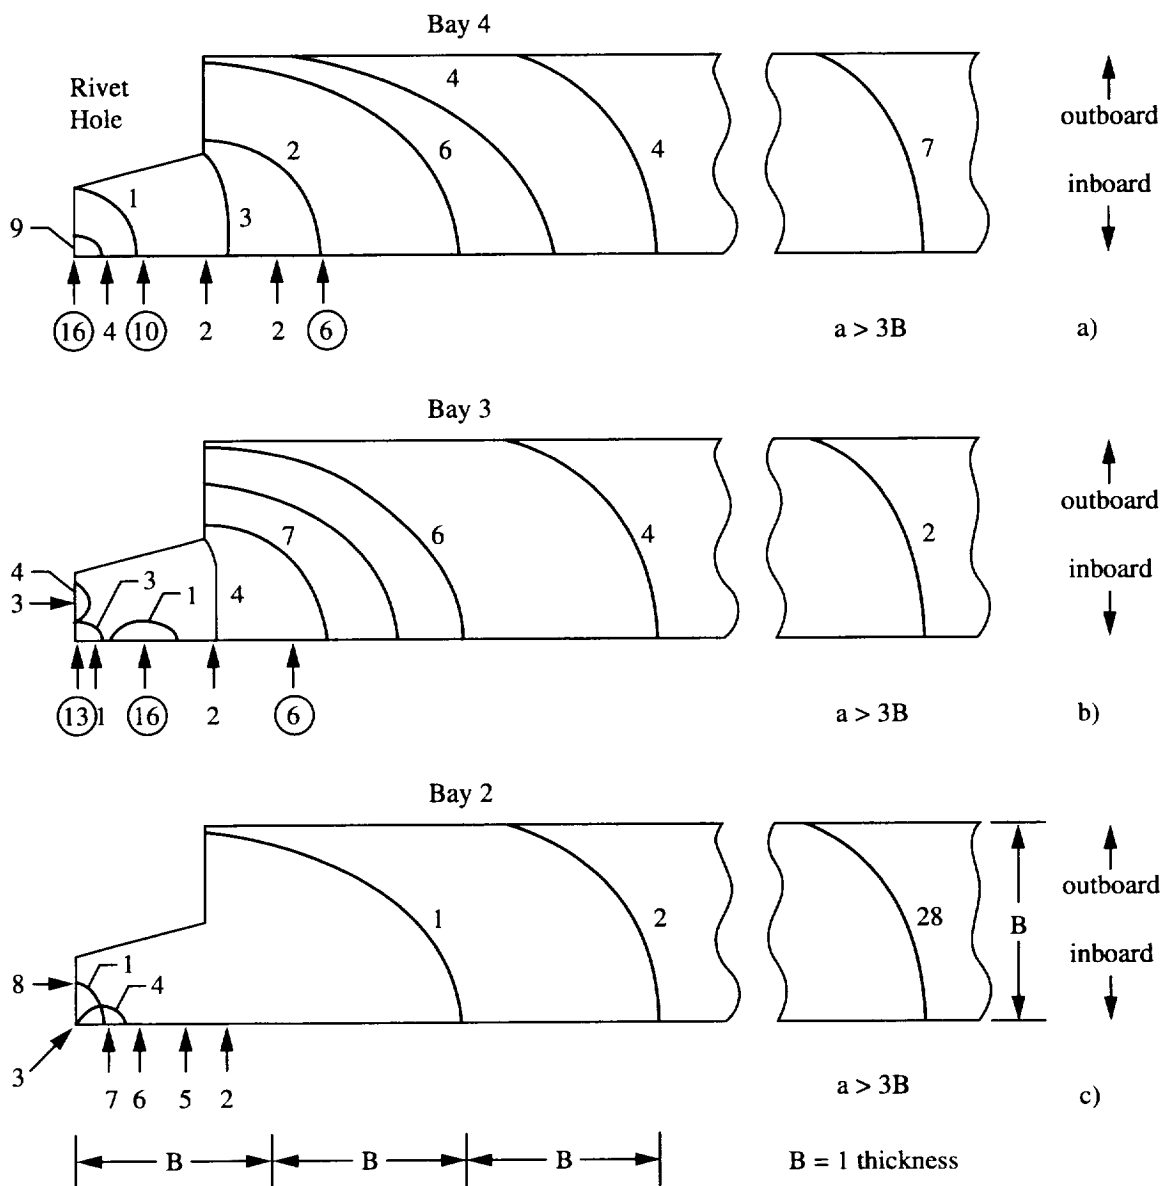
The schematics shown in Figures 12.1 and 12.2 summarize the cracking in lap splice bays 2, 3, and 4. The majority of lap splice outer skin fatigue cracks initiated along the faying surface (Figure 12.1) or at the inboard corner of the rivet hole and propagated as subsurface fatigue cracks for a substantial length before penetrating the outboard surface. Note that bays 3 and 4 exhibited three dominant crack initiation sites (circled numbers) along the faying surface. Most fatigue cracks initiated along the faying surface or near the inboard corner of the rivet hole. Fewer fatigue cracks initiated in the rivet hole shank region. Lap splice inner skin fatigue cracks shown in Figure 12.2 are isolated to the bottom two rivet rows in bays 2, 3, and 4. Most inner skin fatigue cracks initiated at the inboard corner of the rivet hole. The inner skin cracks found in bays 3 and 4 are small compared to those observed in bay 2. Presumably, bay 2 inner skin loads were higher compared to inner skin loads in bays 3 and 4, a likely result of crack link-up that occurred along bay 2 outer skin upper rivet row. A summary of crack initiation sites in bay 2/3 and 3/4 tear strap regions are shown in Figures 12.3, 12.4, 12.5 and 12.6. Most of the fatigue cracks observed in the tear strap region initiated within the rivet hole or at the inboard rivet hole corner.

The summary of crack front shapes from outer skin fatigue cracks is also depicted in Figures 12.1 through 12.6. Indicated adjacent to each crack front is the number of fatigue cracks observed with similar final crack front shape and crack length. For example in Figure 12.1, two bay 2, four bay 3, and four bay 4 cracks exhibited similar crack front shapes at a crack length of $3B$, where B is the skin thickness. Note that bay 2 contained 28 fatigue cracks of lengths greater than $3B$; these cracks were located in the upper rivet row, where crack link-up occurred, forming the long crack. These results show that all outer skin fatigue cracks grow with similar crack front shapes and crack lengths range from two to three skin thicknesses ($2B$ to $3B$) before penetrating the outboard surface of the outer skin. Subsurface cracking noted in the outer skin may result from two effects, (1) out-of-plane bending, and/or (2) residual compressive stress imparted by the radial expansion of the rivet head into the counter bore region. Both effects limit fatigue crack growth in the outboard direction and possibly promote the observed outer skin subsurface fatigue cracking. Different crack front shapes are noted along the inner skin shown in Figure 12.2. The irregular inner skin crack front shape noted in bay 2 is likely due to multiple cracks coalescing along the outboard surface.

Figure 12.1 A schematic of the lap splice outer skin rivet hole region summarizes the location of fatigue crack initiation sites (arrows) and the final fatigue crack front configuration (curved lines) for a) bay 4, b) bay 3, and c) bay 2. The numbers denote the quantity of fatigue cracks or initiation sites found in the given crack front and initiation regions.

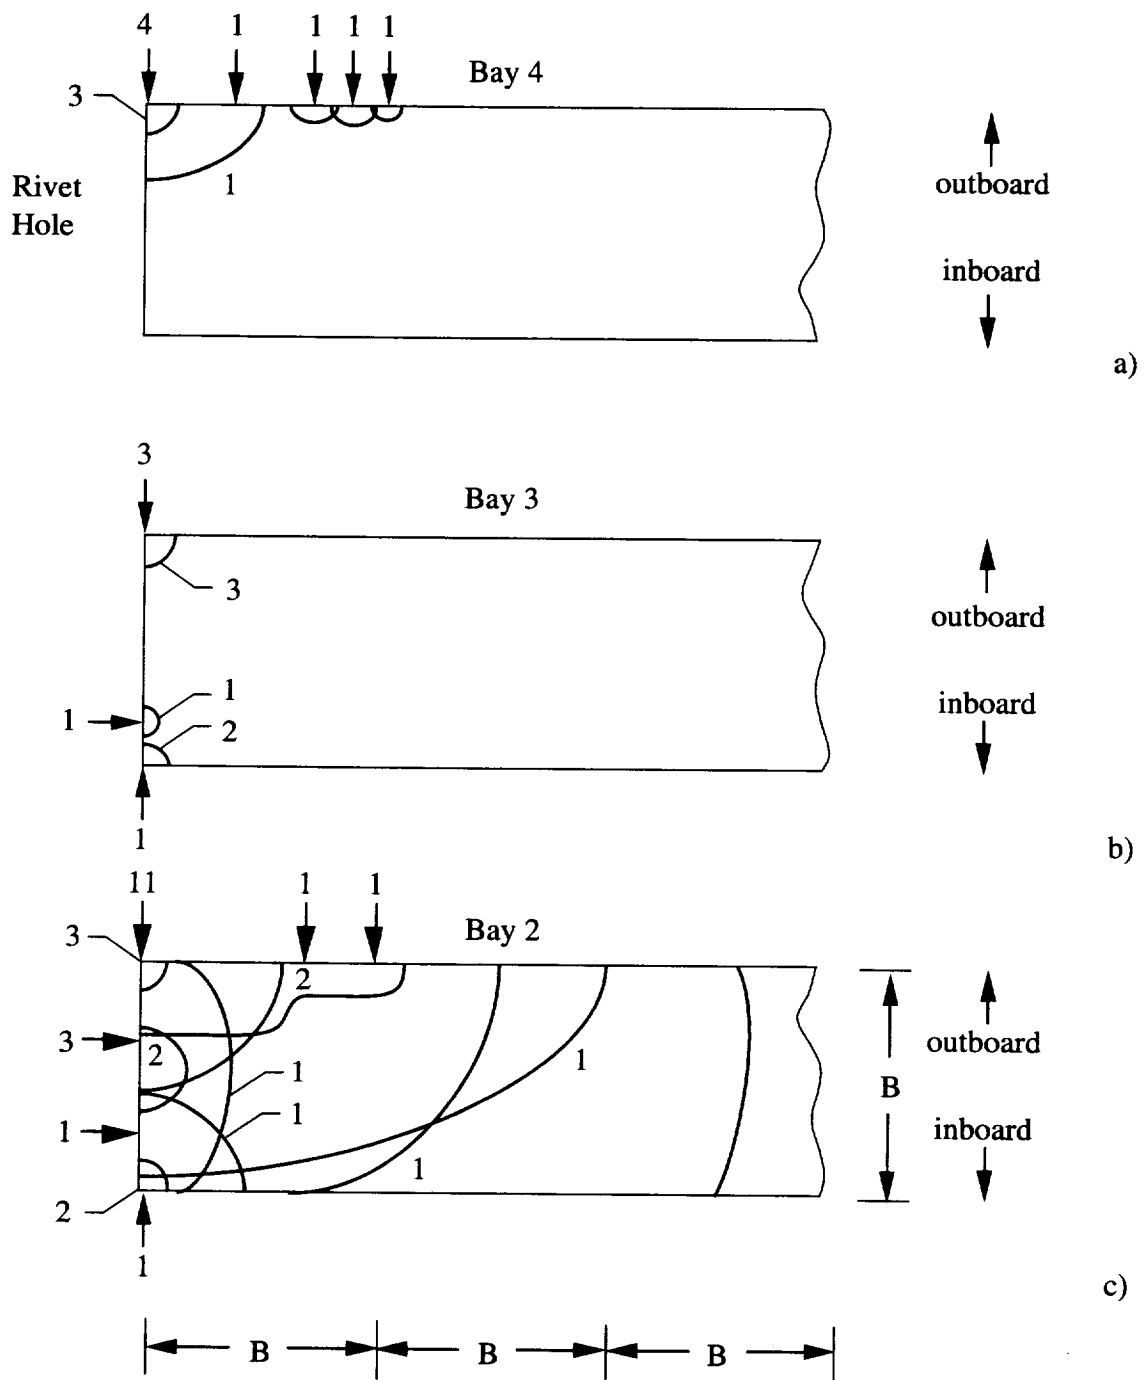
Figure 12.2 A schematic of the lap splice inner skin rivet hole region summarizes the location of fatigue crack initiation (arrows) and the final fatigue crack front configuration (curved lines) for a) bay 4, b) bay 3, and c) bay 2. The numbers denote the quantity of fatigue cracks or initiation sites found in the given crack front and initiation regions.

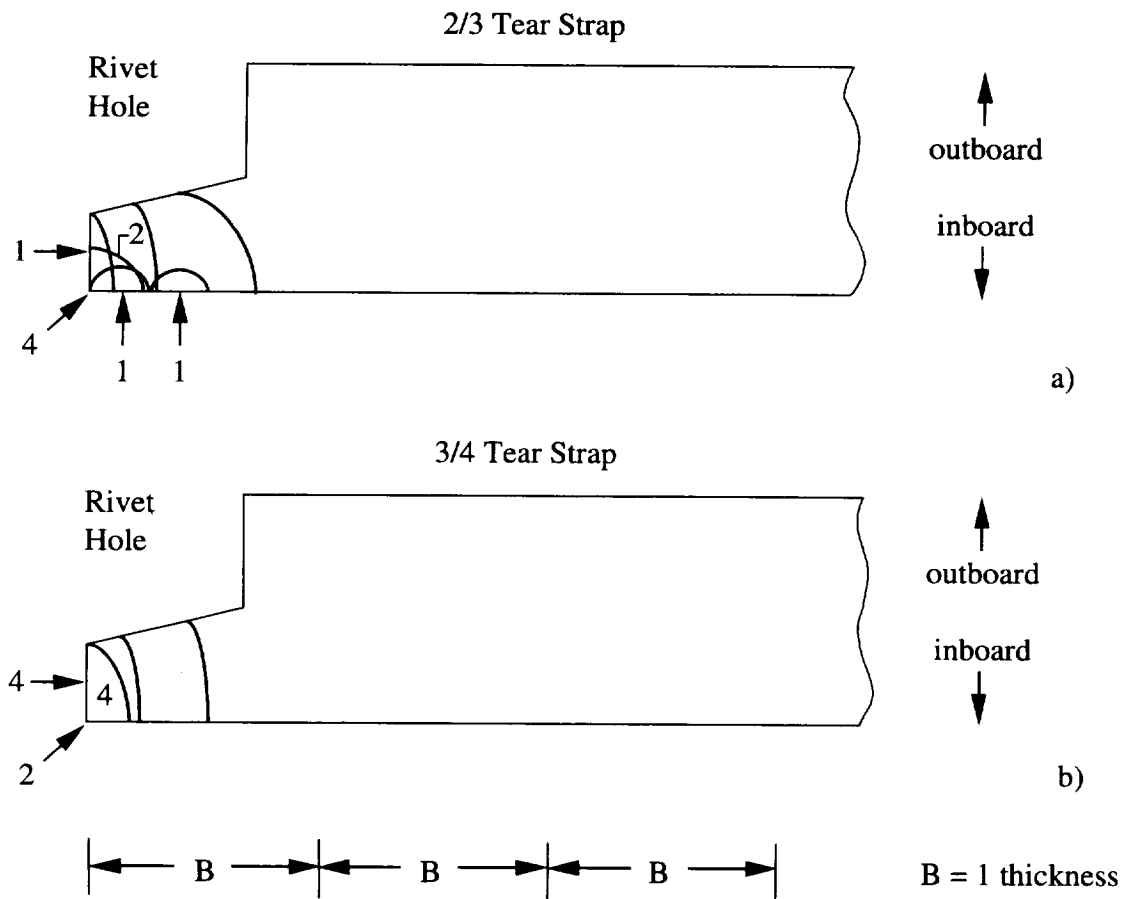
The schematic shown in Figure 12.3 reveals the crack front shape for fatigue cracks contained in the lap

splice outer skin for the 2/3 and 3/4 tear strap regions. All fatigue cracks found in the outer skin were small, although, these limited data suggest similar crack front shapes to those contained in bays 2, 3, and 4. Fatigue cracks contained in the lap splice inner skin, Figure 12.4, and tear straps, Figures 12.5 and 12.6, are nearly semicircular or quarter-circular in shape. This symmetry may suggest minimal out-of-plane loading in the tear strap.

Figure 12.3 A schematic of a) bay 2/3 tear strap and b) bay 3/4 tear strap outer skin rivet hole region and the location of fatigue crack initiation (arrows) and the final fatigue crack front configuration (curved lines). The numbers denote the quantity of fatigue cracks or initiation sites found in the given crack front and initiation regions.
